# Walk Around

## Focke-Wulf Fw 190A/F

Walk Around Number 22  
squadron/signal publications

By Malcolm Laing and E. Brown Ryle

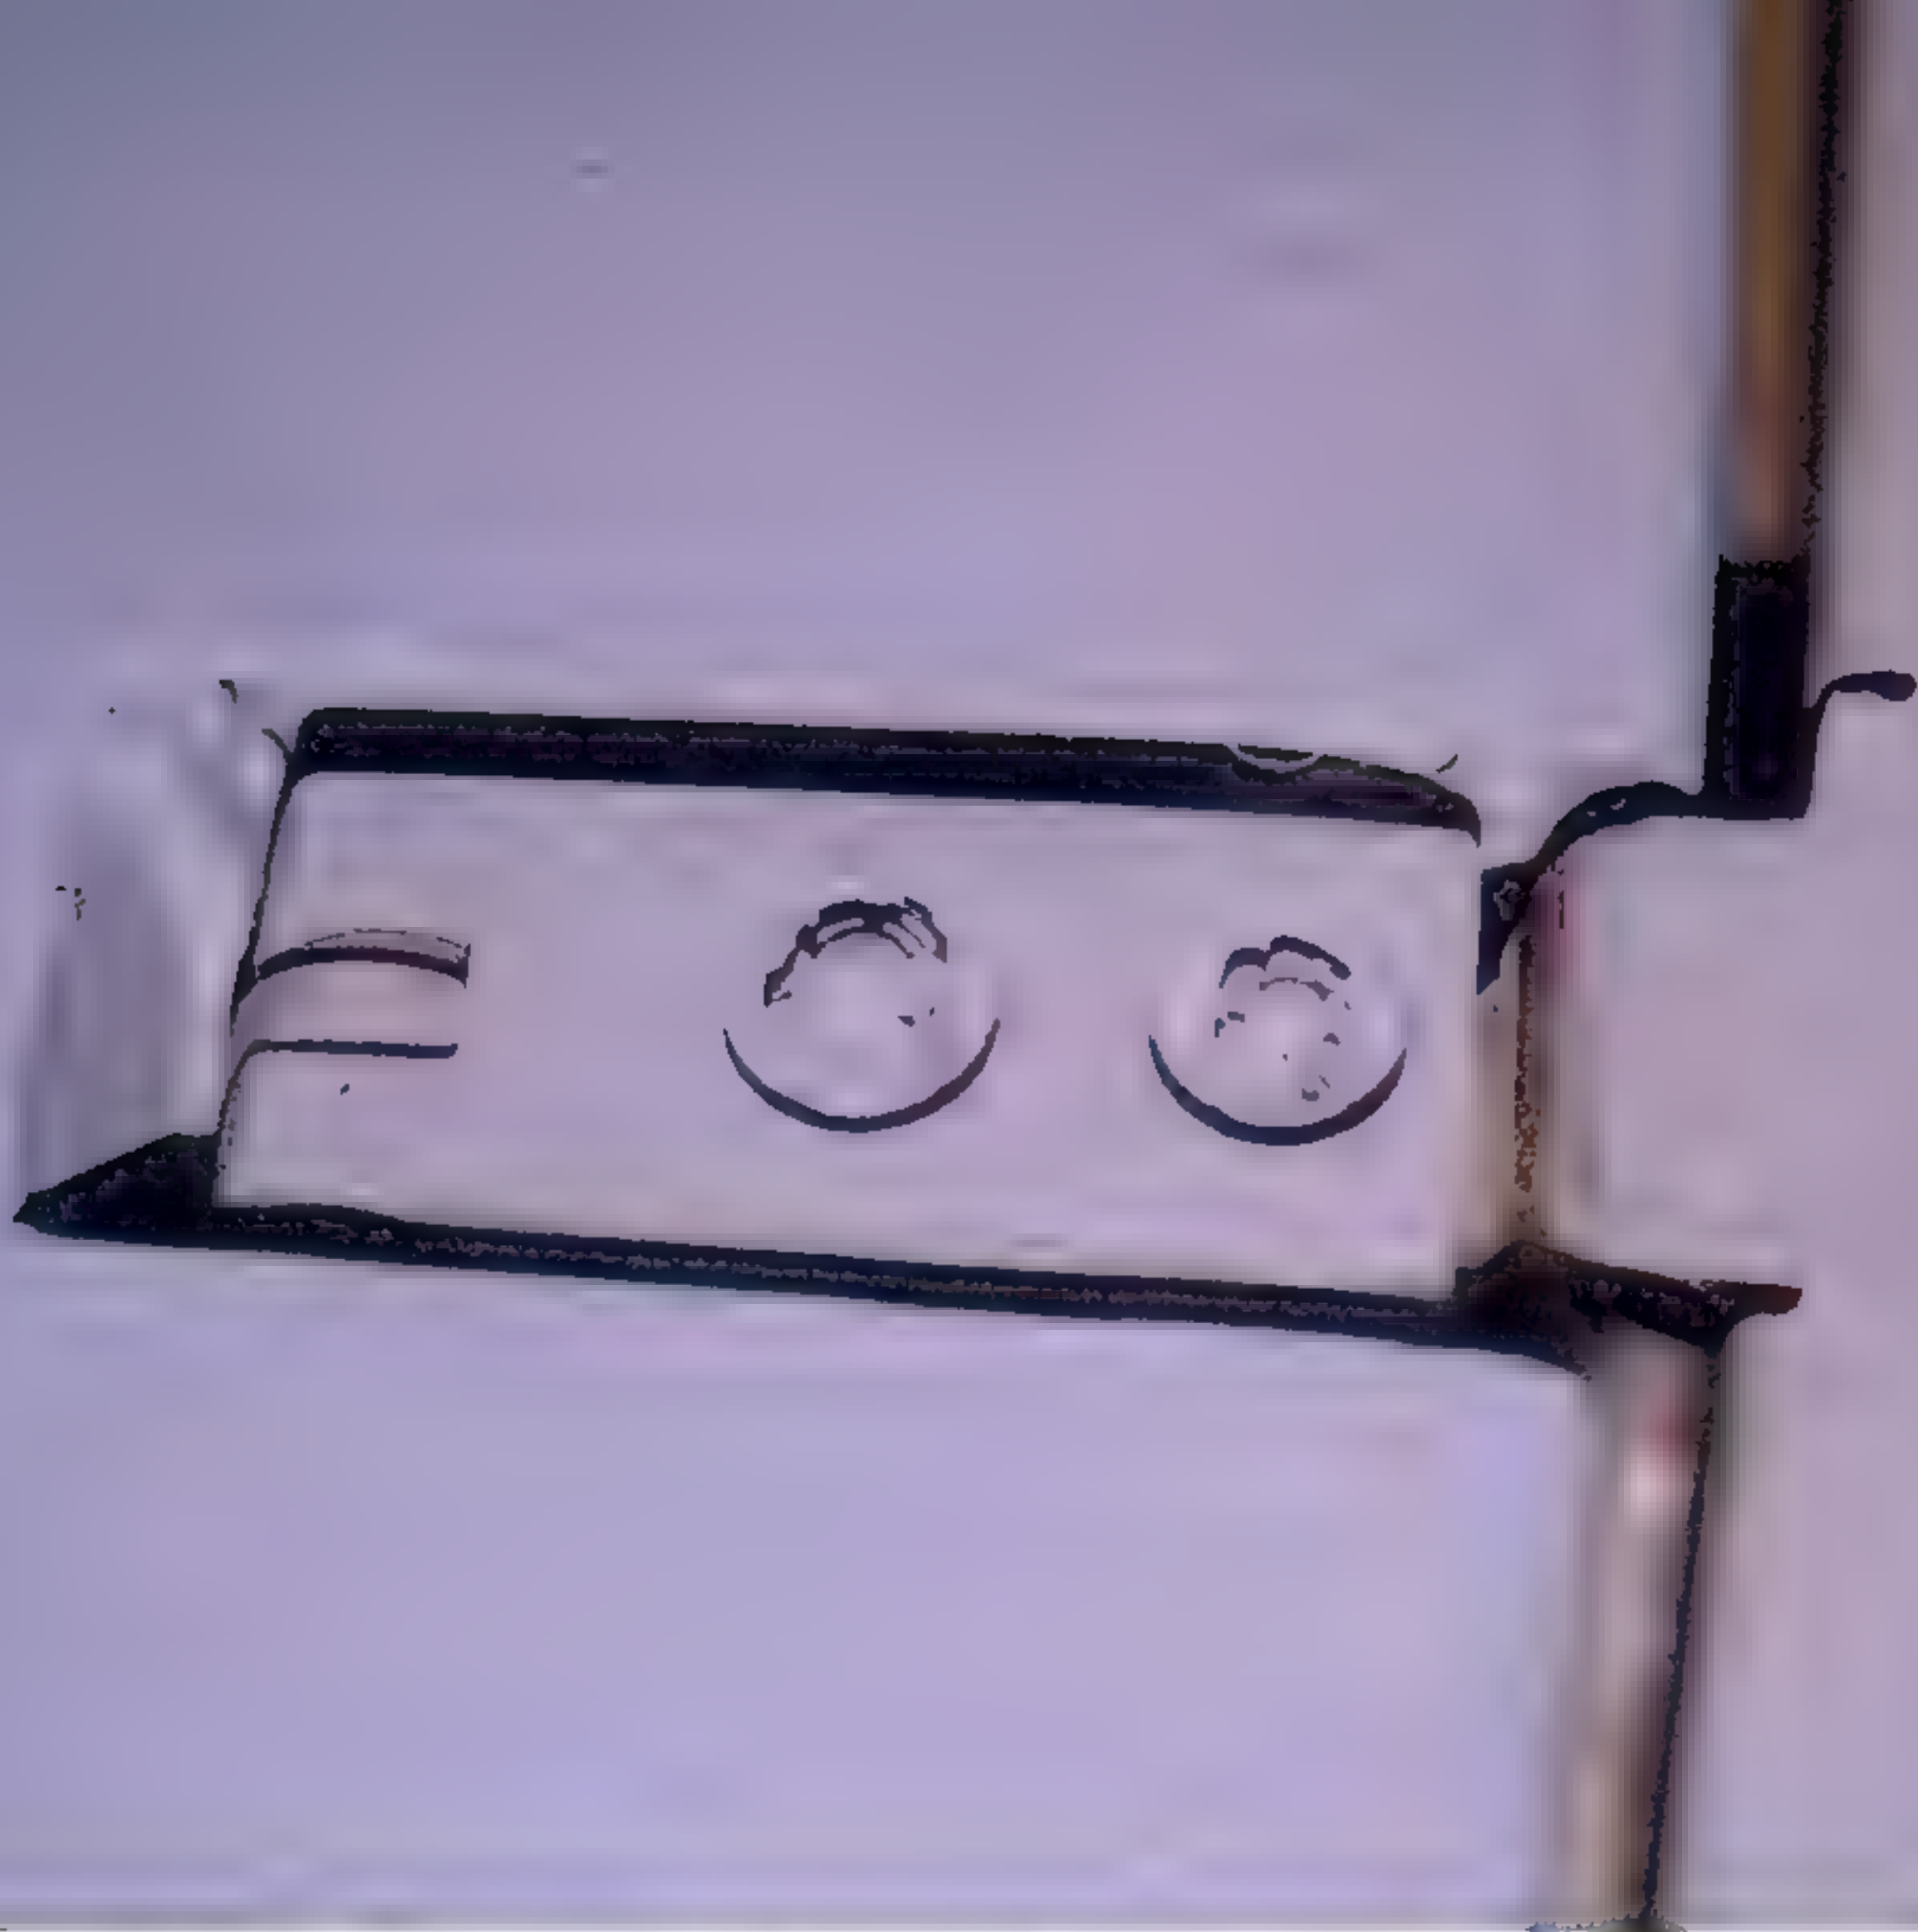
**Each Fw 190 aileron is attached to the wing by three fittings; this is the center fitting under the port wing. These fittings allowed for some variation in size or location in attaching the aileron, due to the numerous sub contractors producing ailerons and other small parts for the Fw 190. (Ryle)**

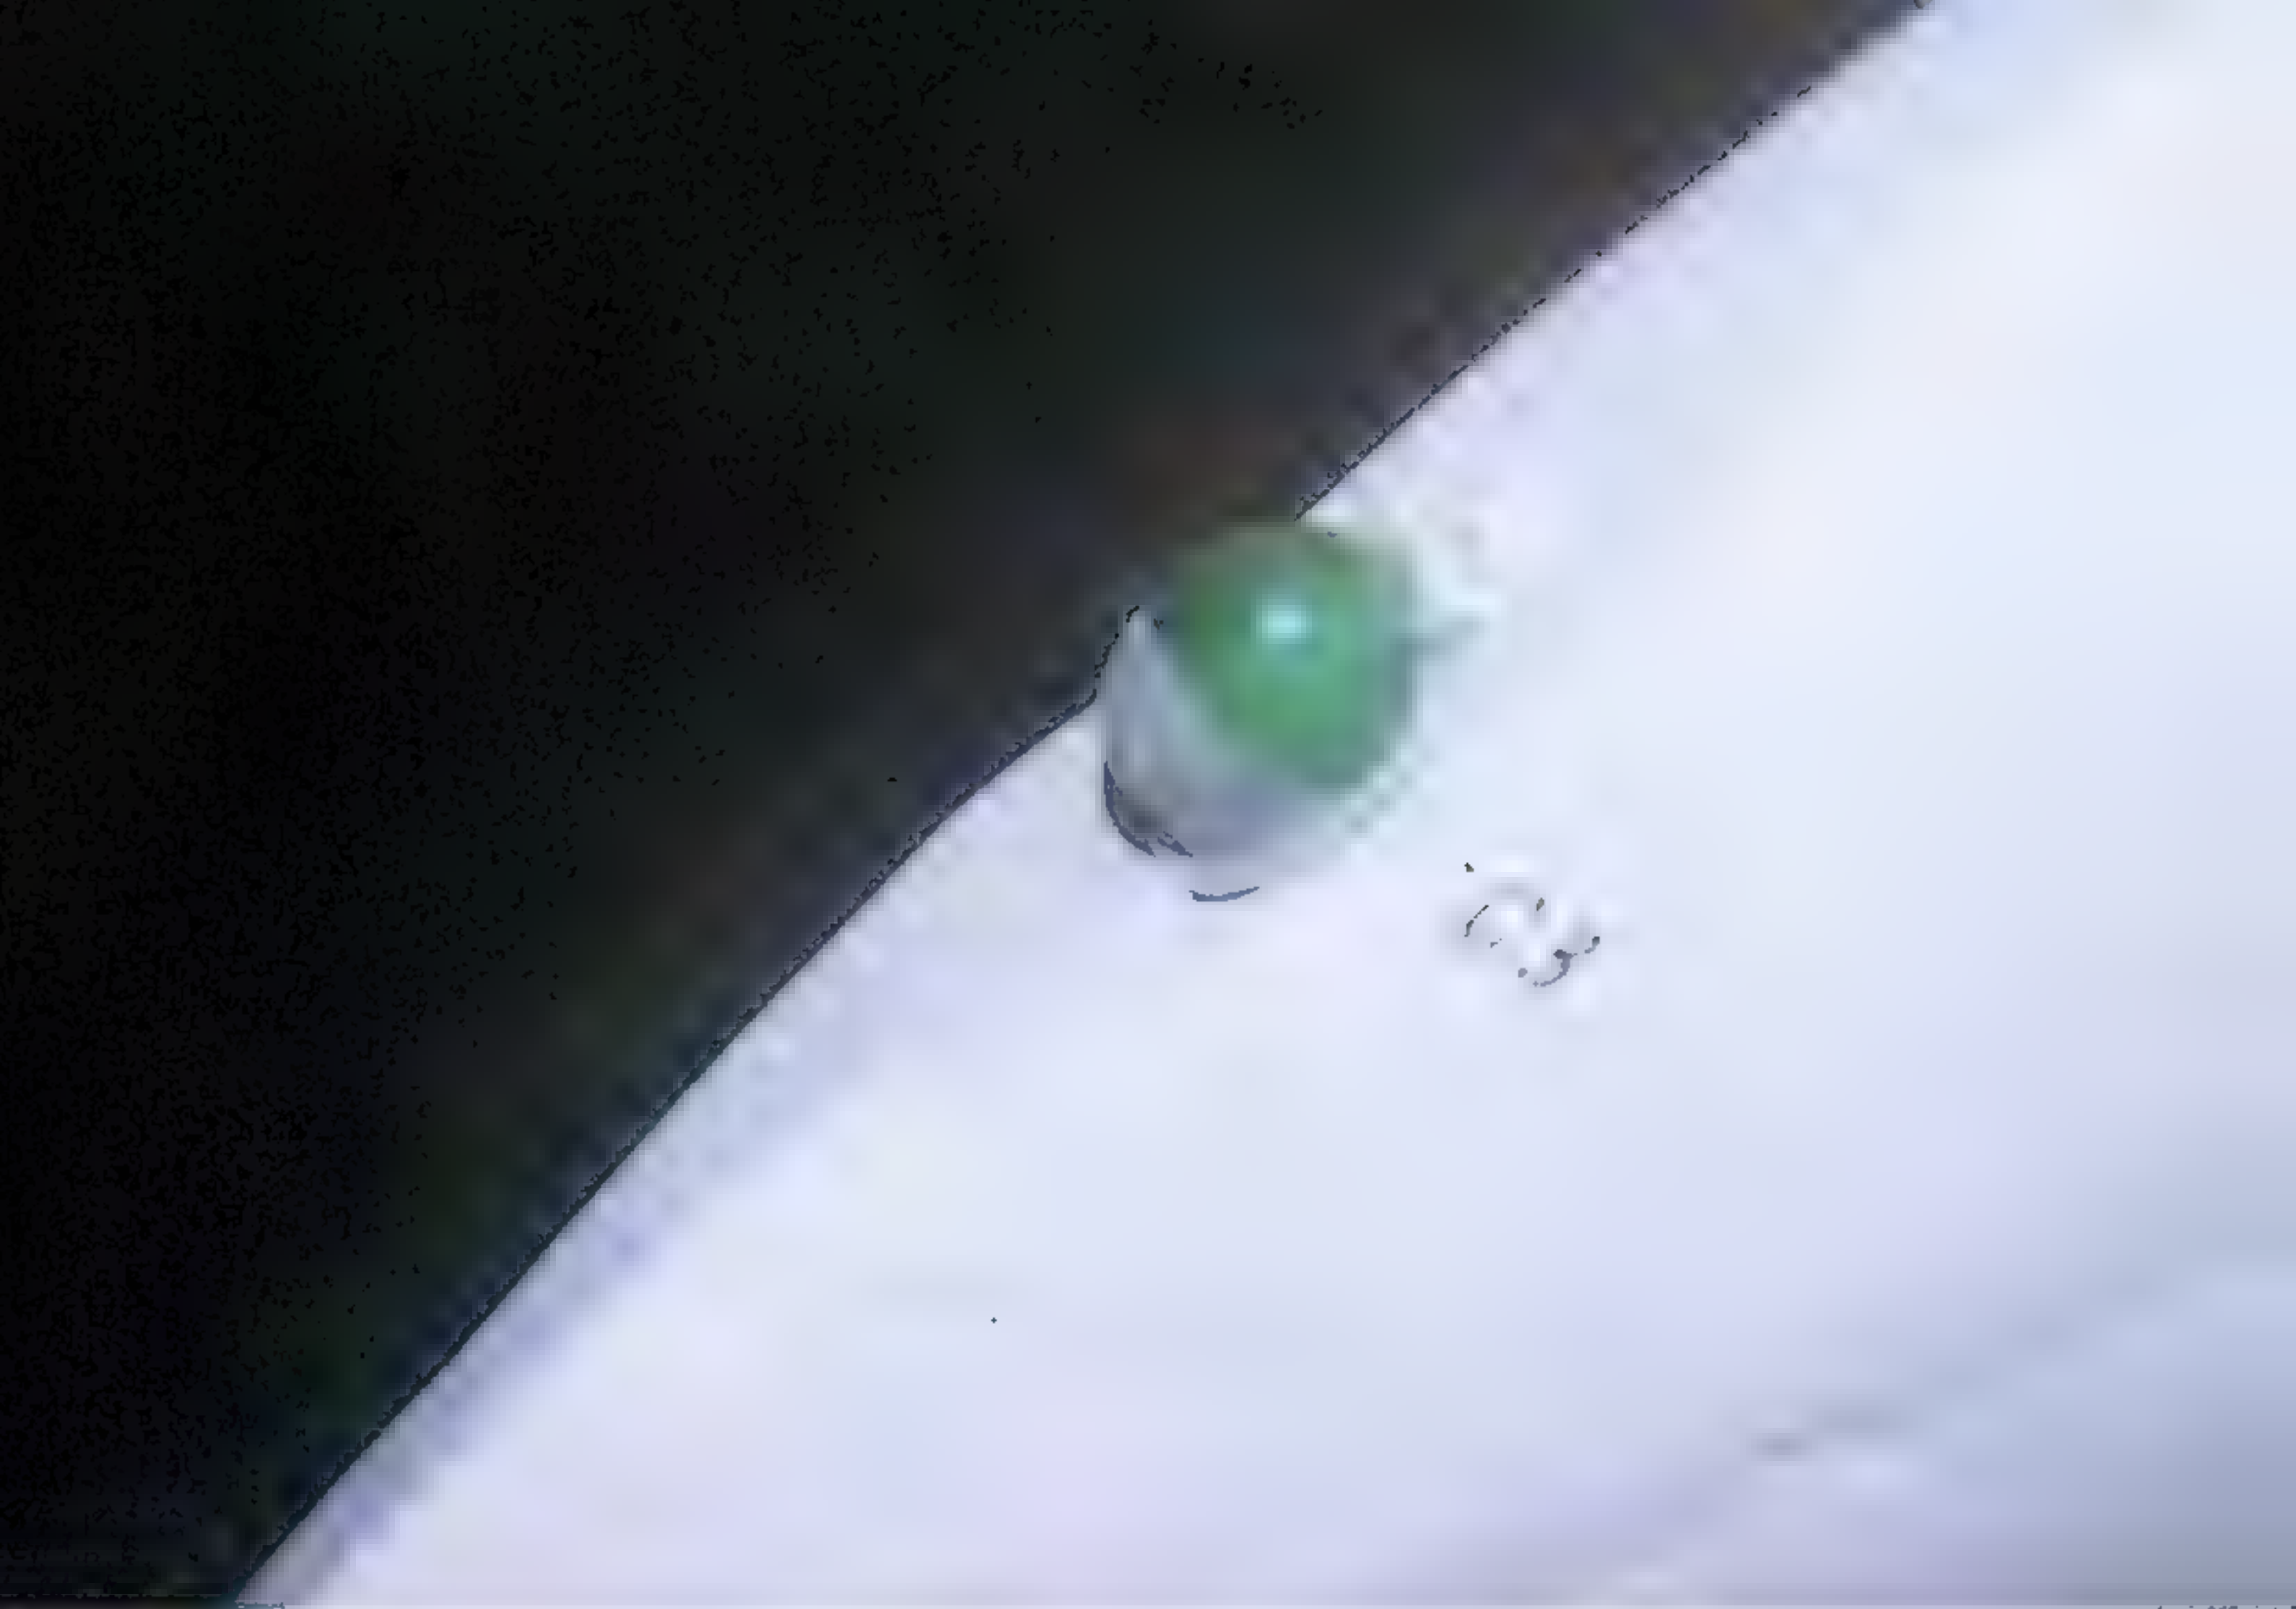
The Fw 190F-8's starboard wingtip navigation light is green; a red light appears on the port wingtip. The F series used a rounder navigation light than the teardrop-shaped style lights employed by earlier Fw 190s. The original design was interchangeable with these later lights. The rear of the light has been painted over with RLM 75 Gray-Violet. The stenciling C3 refers to the electrical harness code for the light. (Ryle)

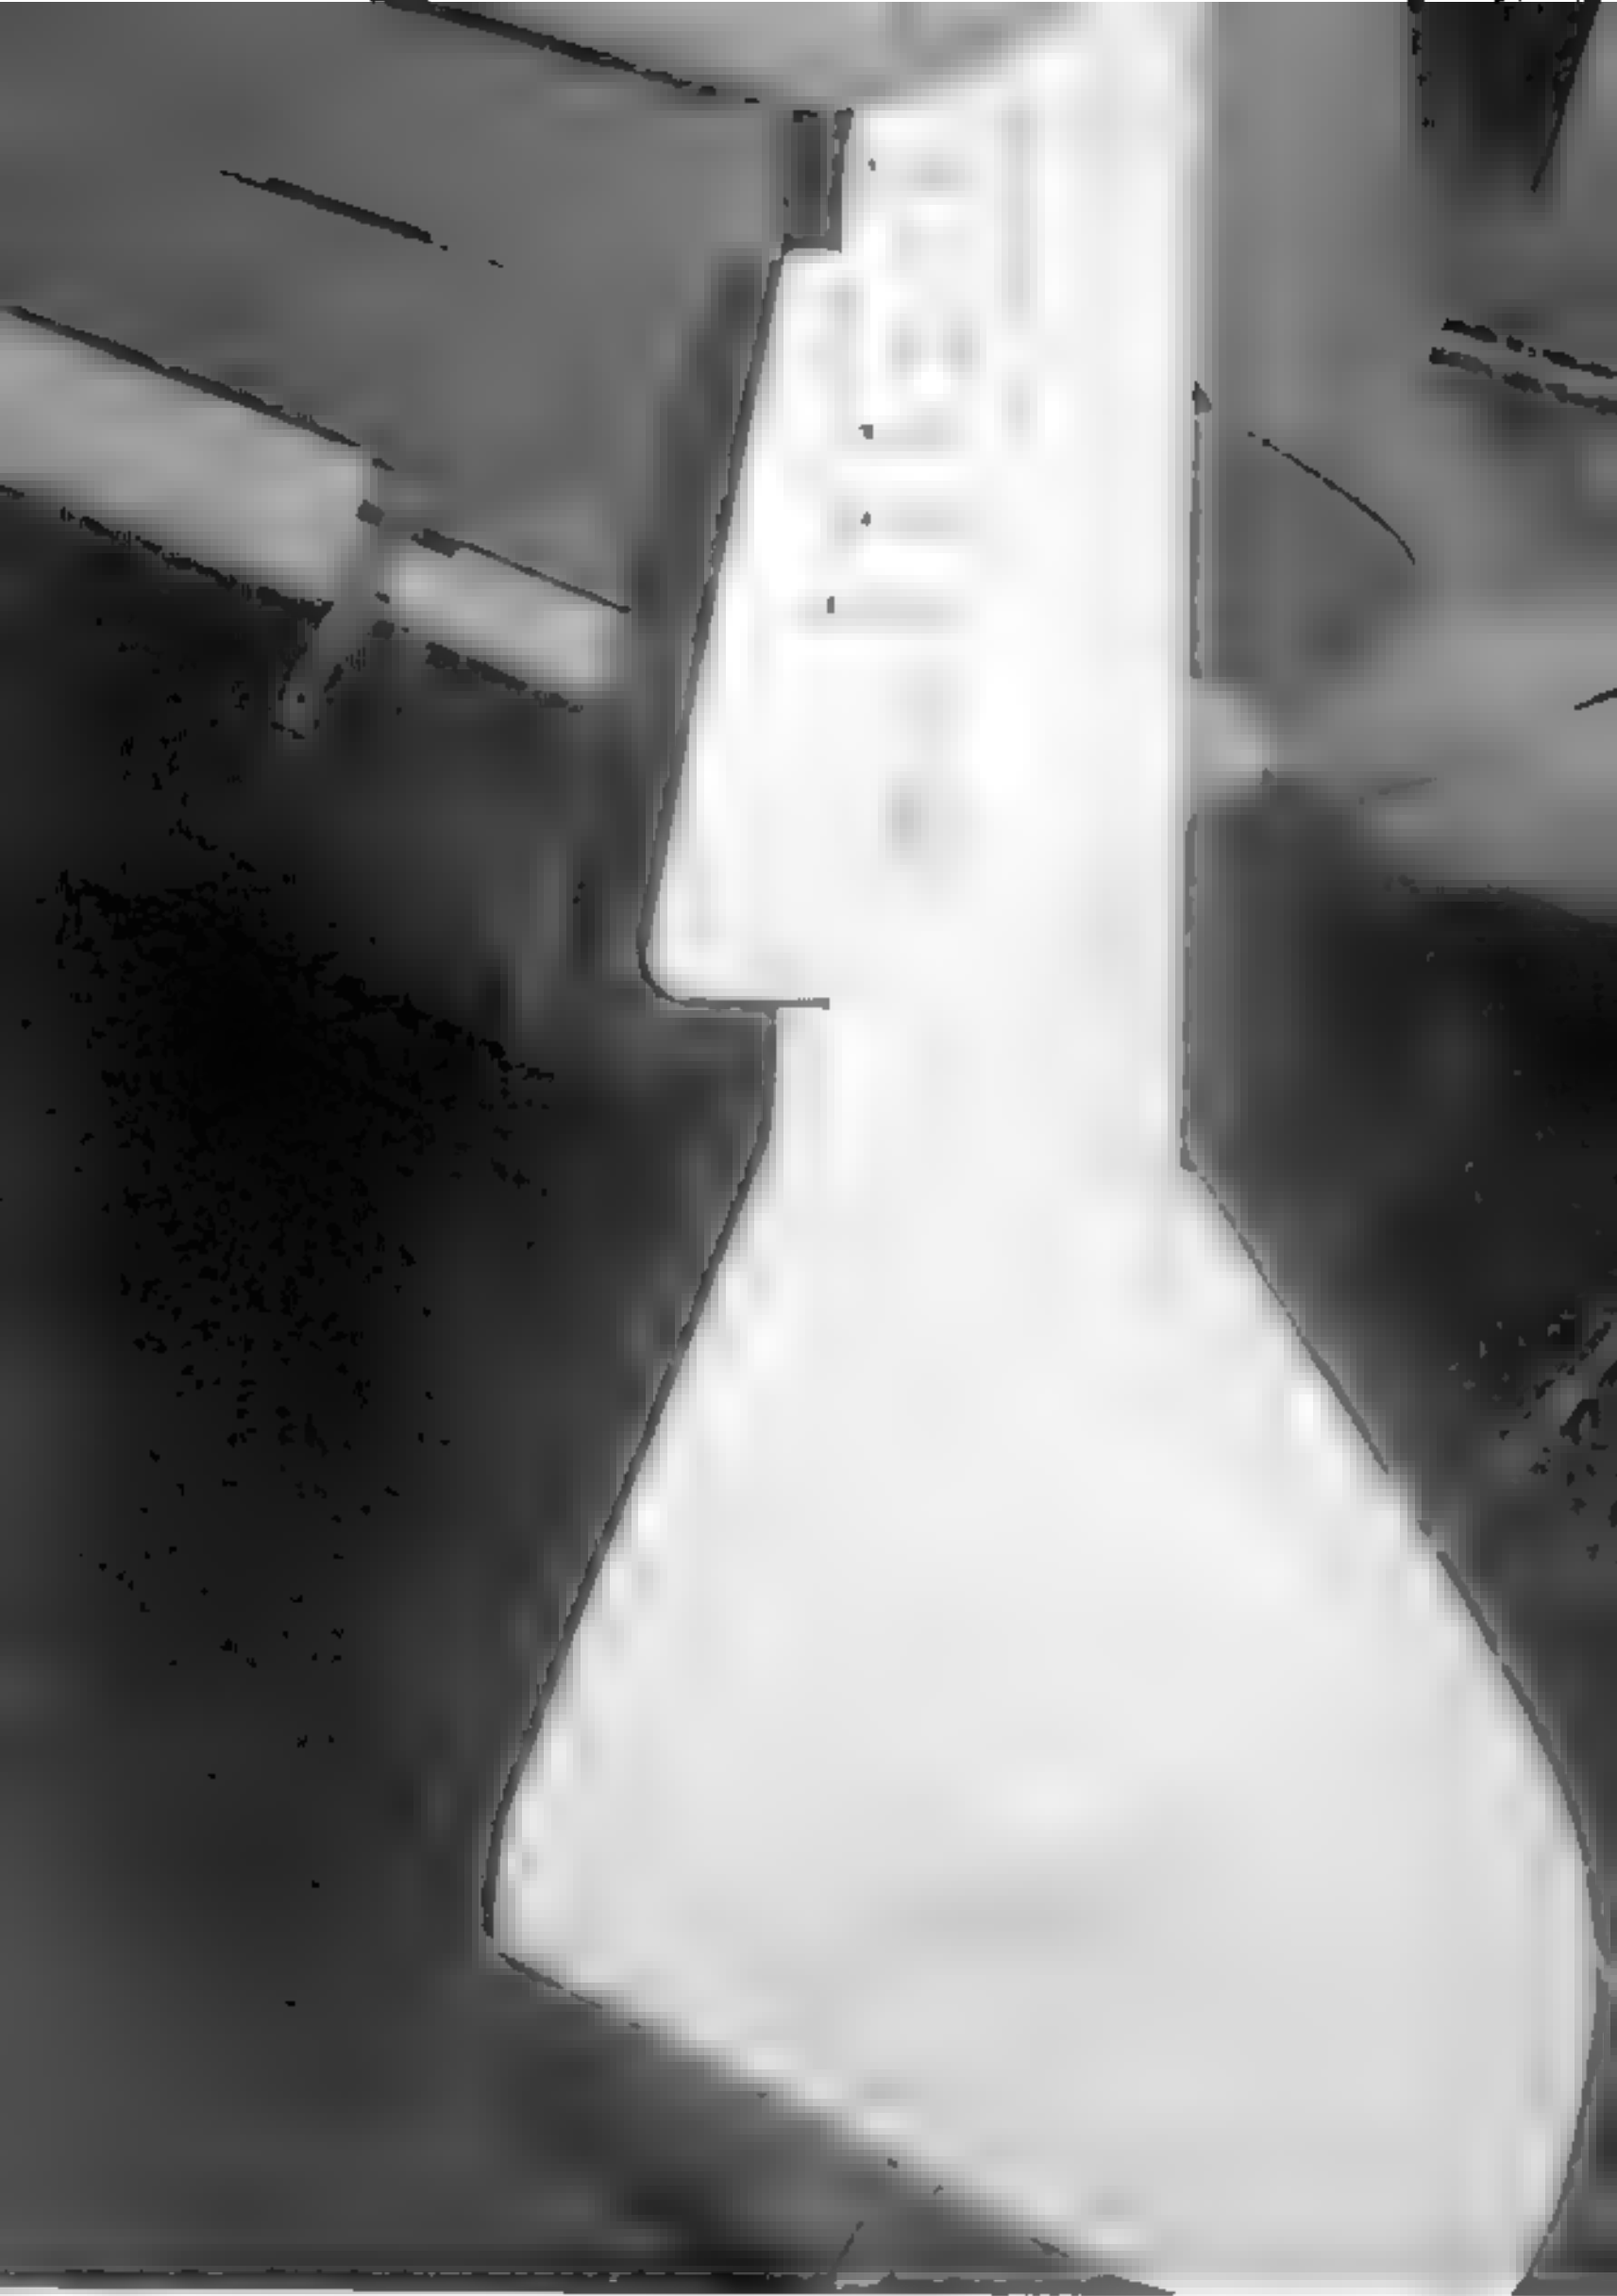
The Fw 190F-8 starboard upper landing gear door is bolted to the main gear strut. The bolt heads are placed in recessed areas of the outside door surface and covered with cloth before painting in the undersurface color. The stenciling on the upper gear door indicated gear strut pressures in atmospheres for different aircraft weights, while the lower door stenciling lists tire pressure in atmospheres for different aircraft weights. These stencils were used on Fw 190s from the A-7 onward. (Ryle)

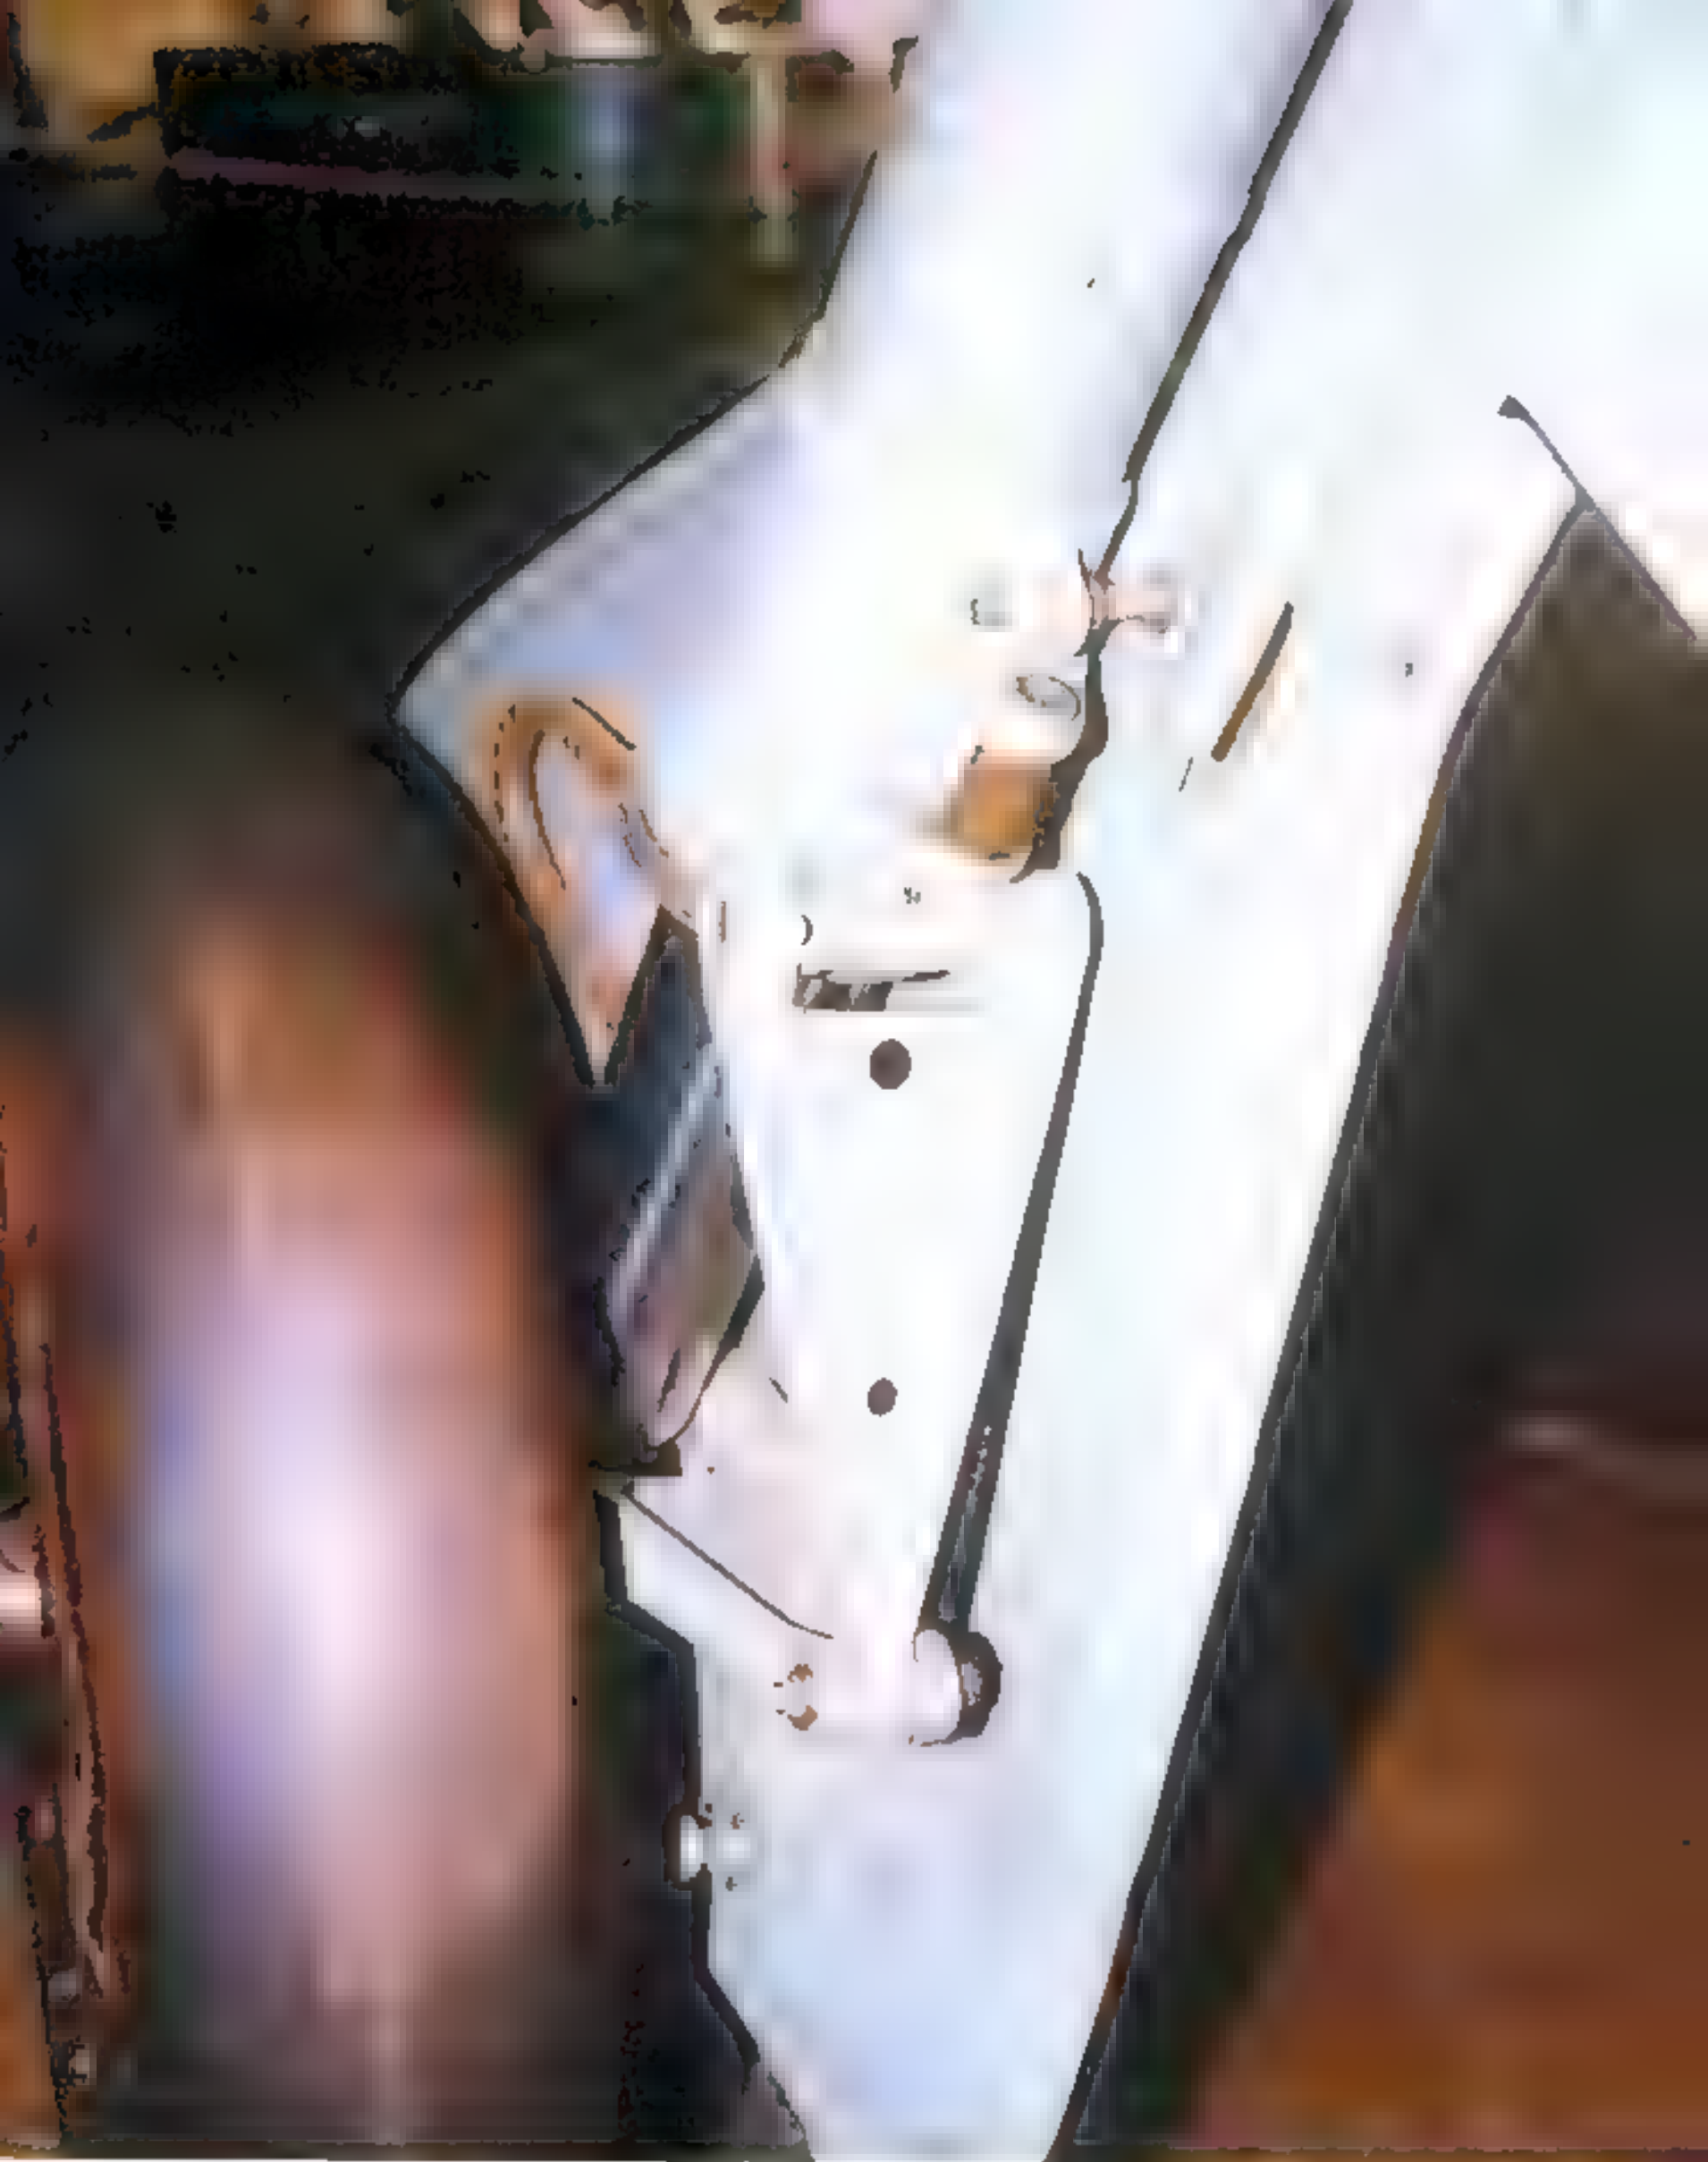
The main landing gear scissor link was attached to the rear of both the upper and lower shock strut sections. These scissors absorbed torque stresses and kept the main wheel correctly aligned. The oleo strut between the scissor arms functioned as a shock absorber to lessen the forces associated with landing and taxiing. The small round fitting immediately above the scissors is the shock strut spur used to lock the main landing gear in the up position. (Ryle)

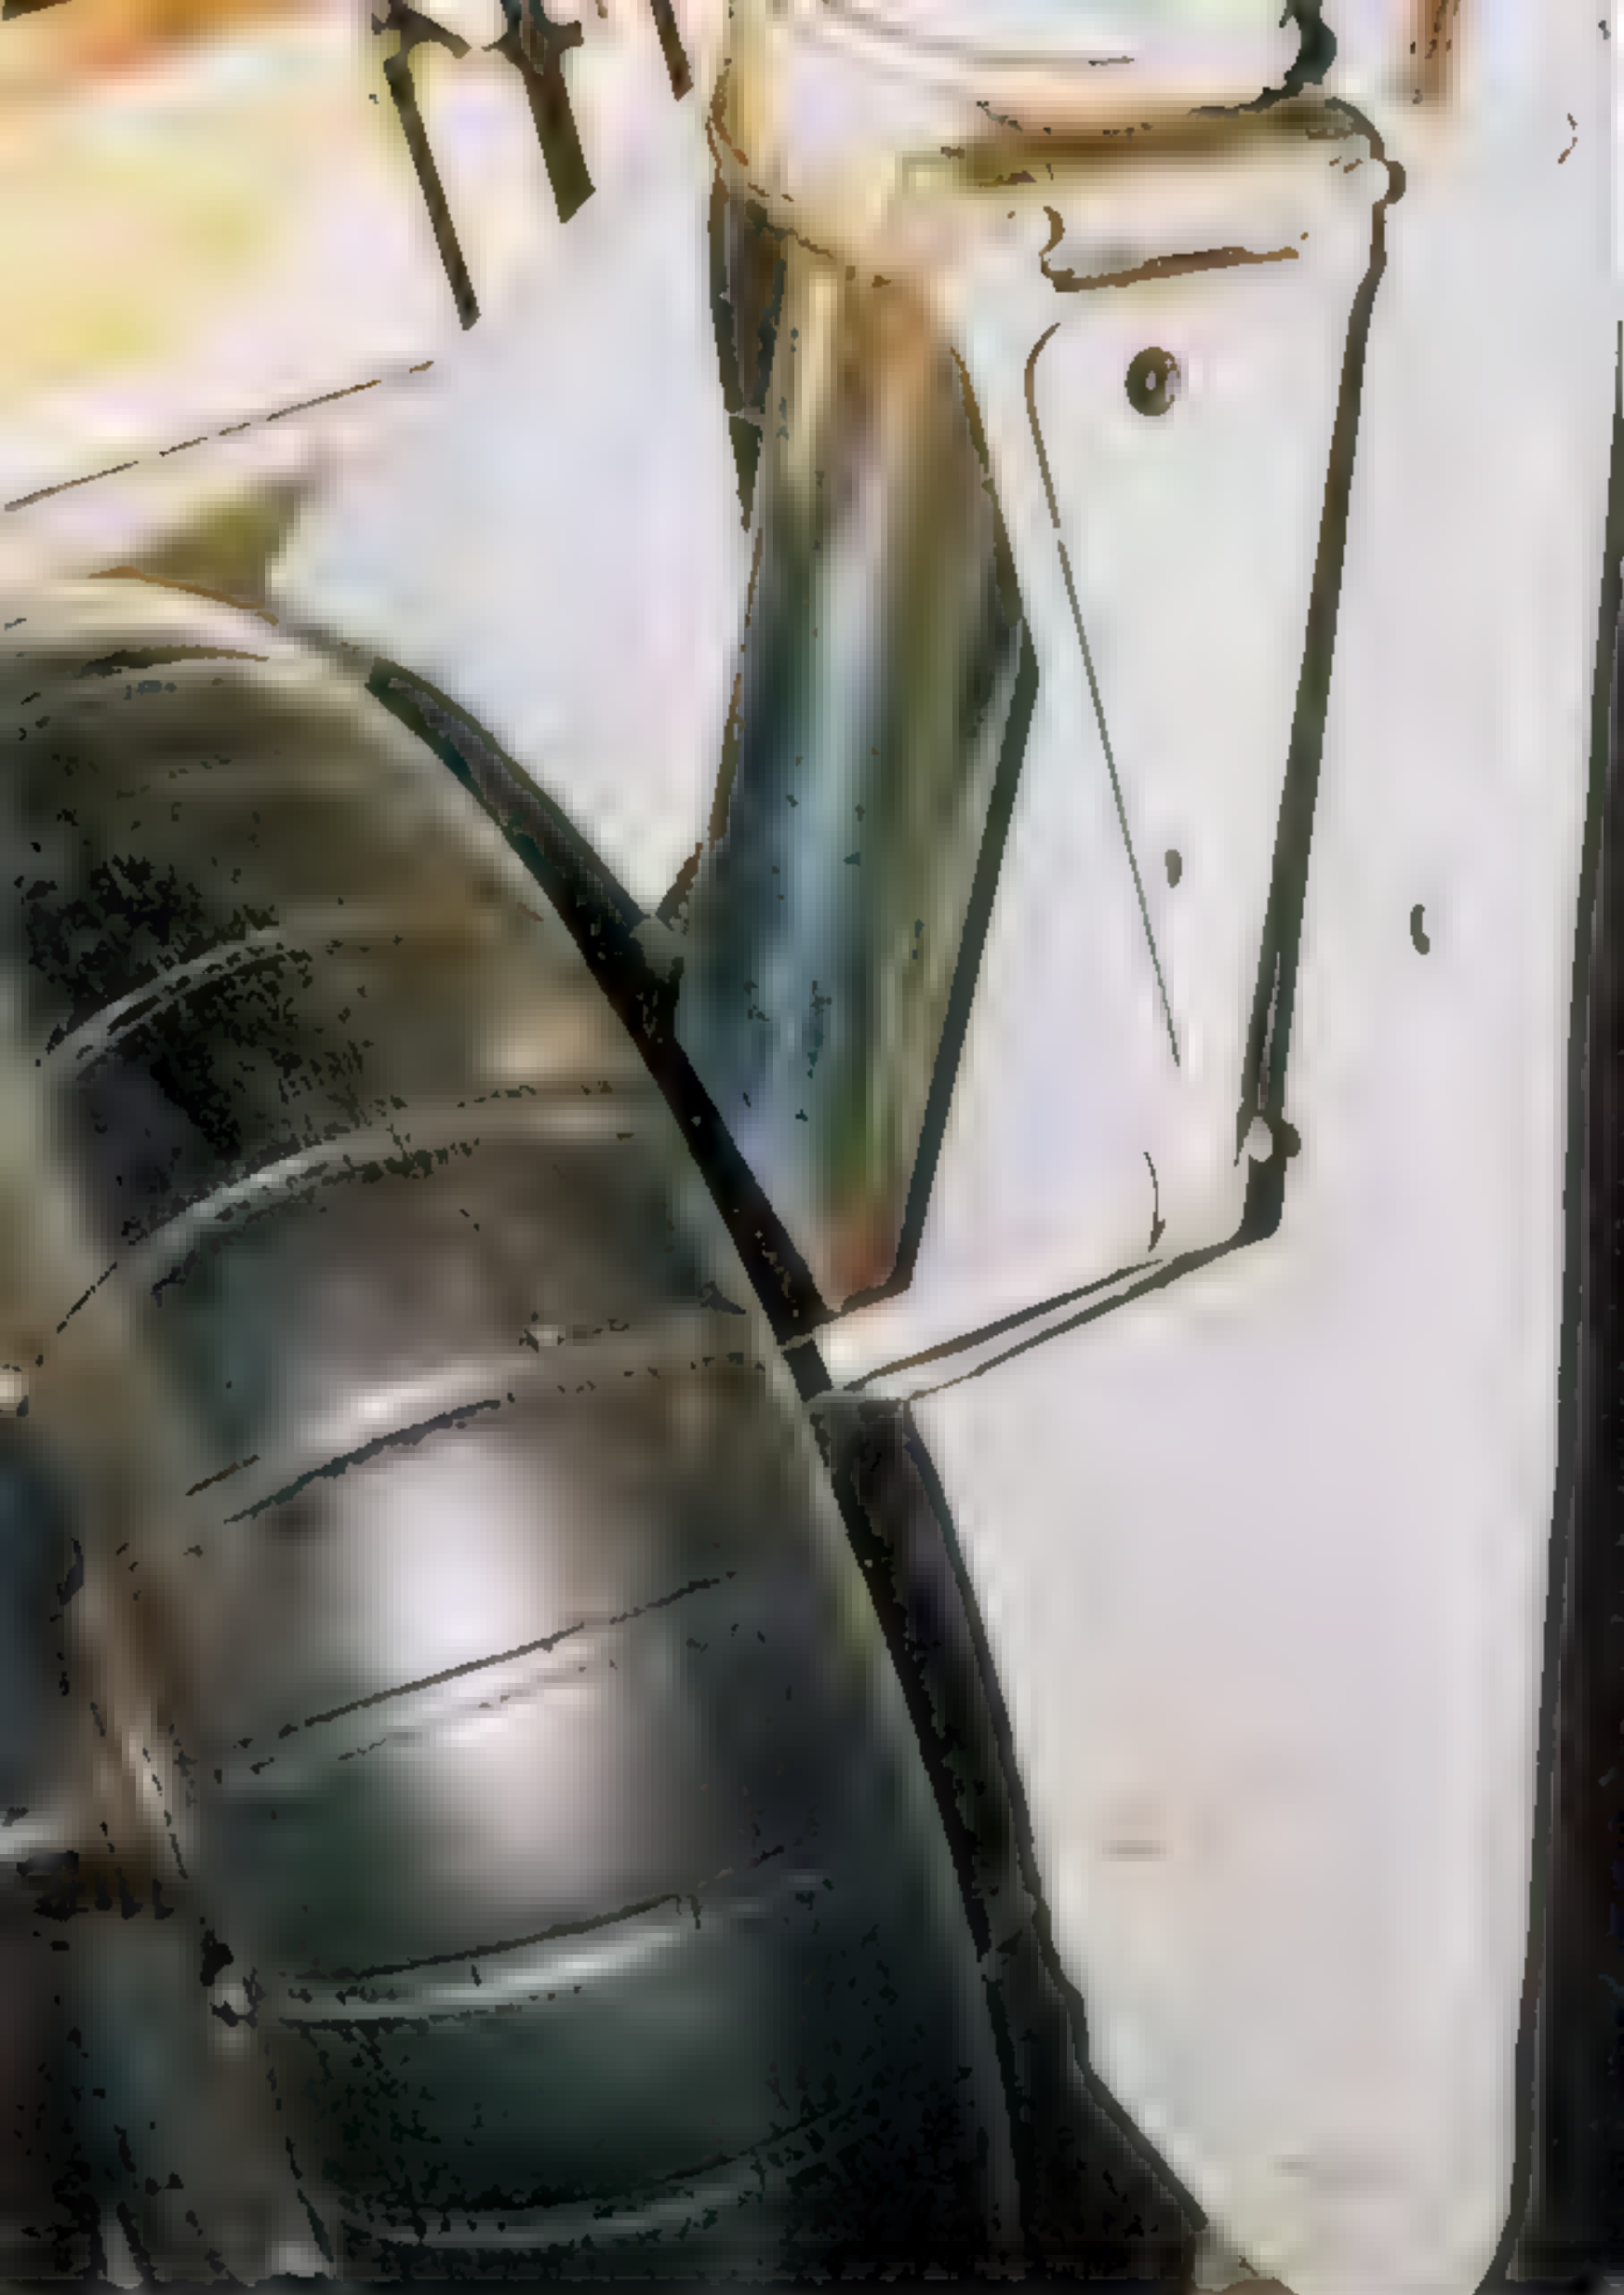
The Fw 190A-6's starboard landing gear is the same unit later used on the F-8. This A-6 is equipped with the more common tire used on Fw 190s. The 700 mm (27.6 inch) by 175 mm (6.9 inch) main tire has a lateral tread pattern used by Fw 190 main tires from 1941 until the end of the war. Carbon black was added to the rubber to give the dark color; this ingredient was often left out of late war tires due to supply shortages. (Ryle)

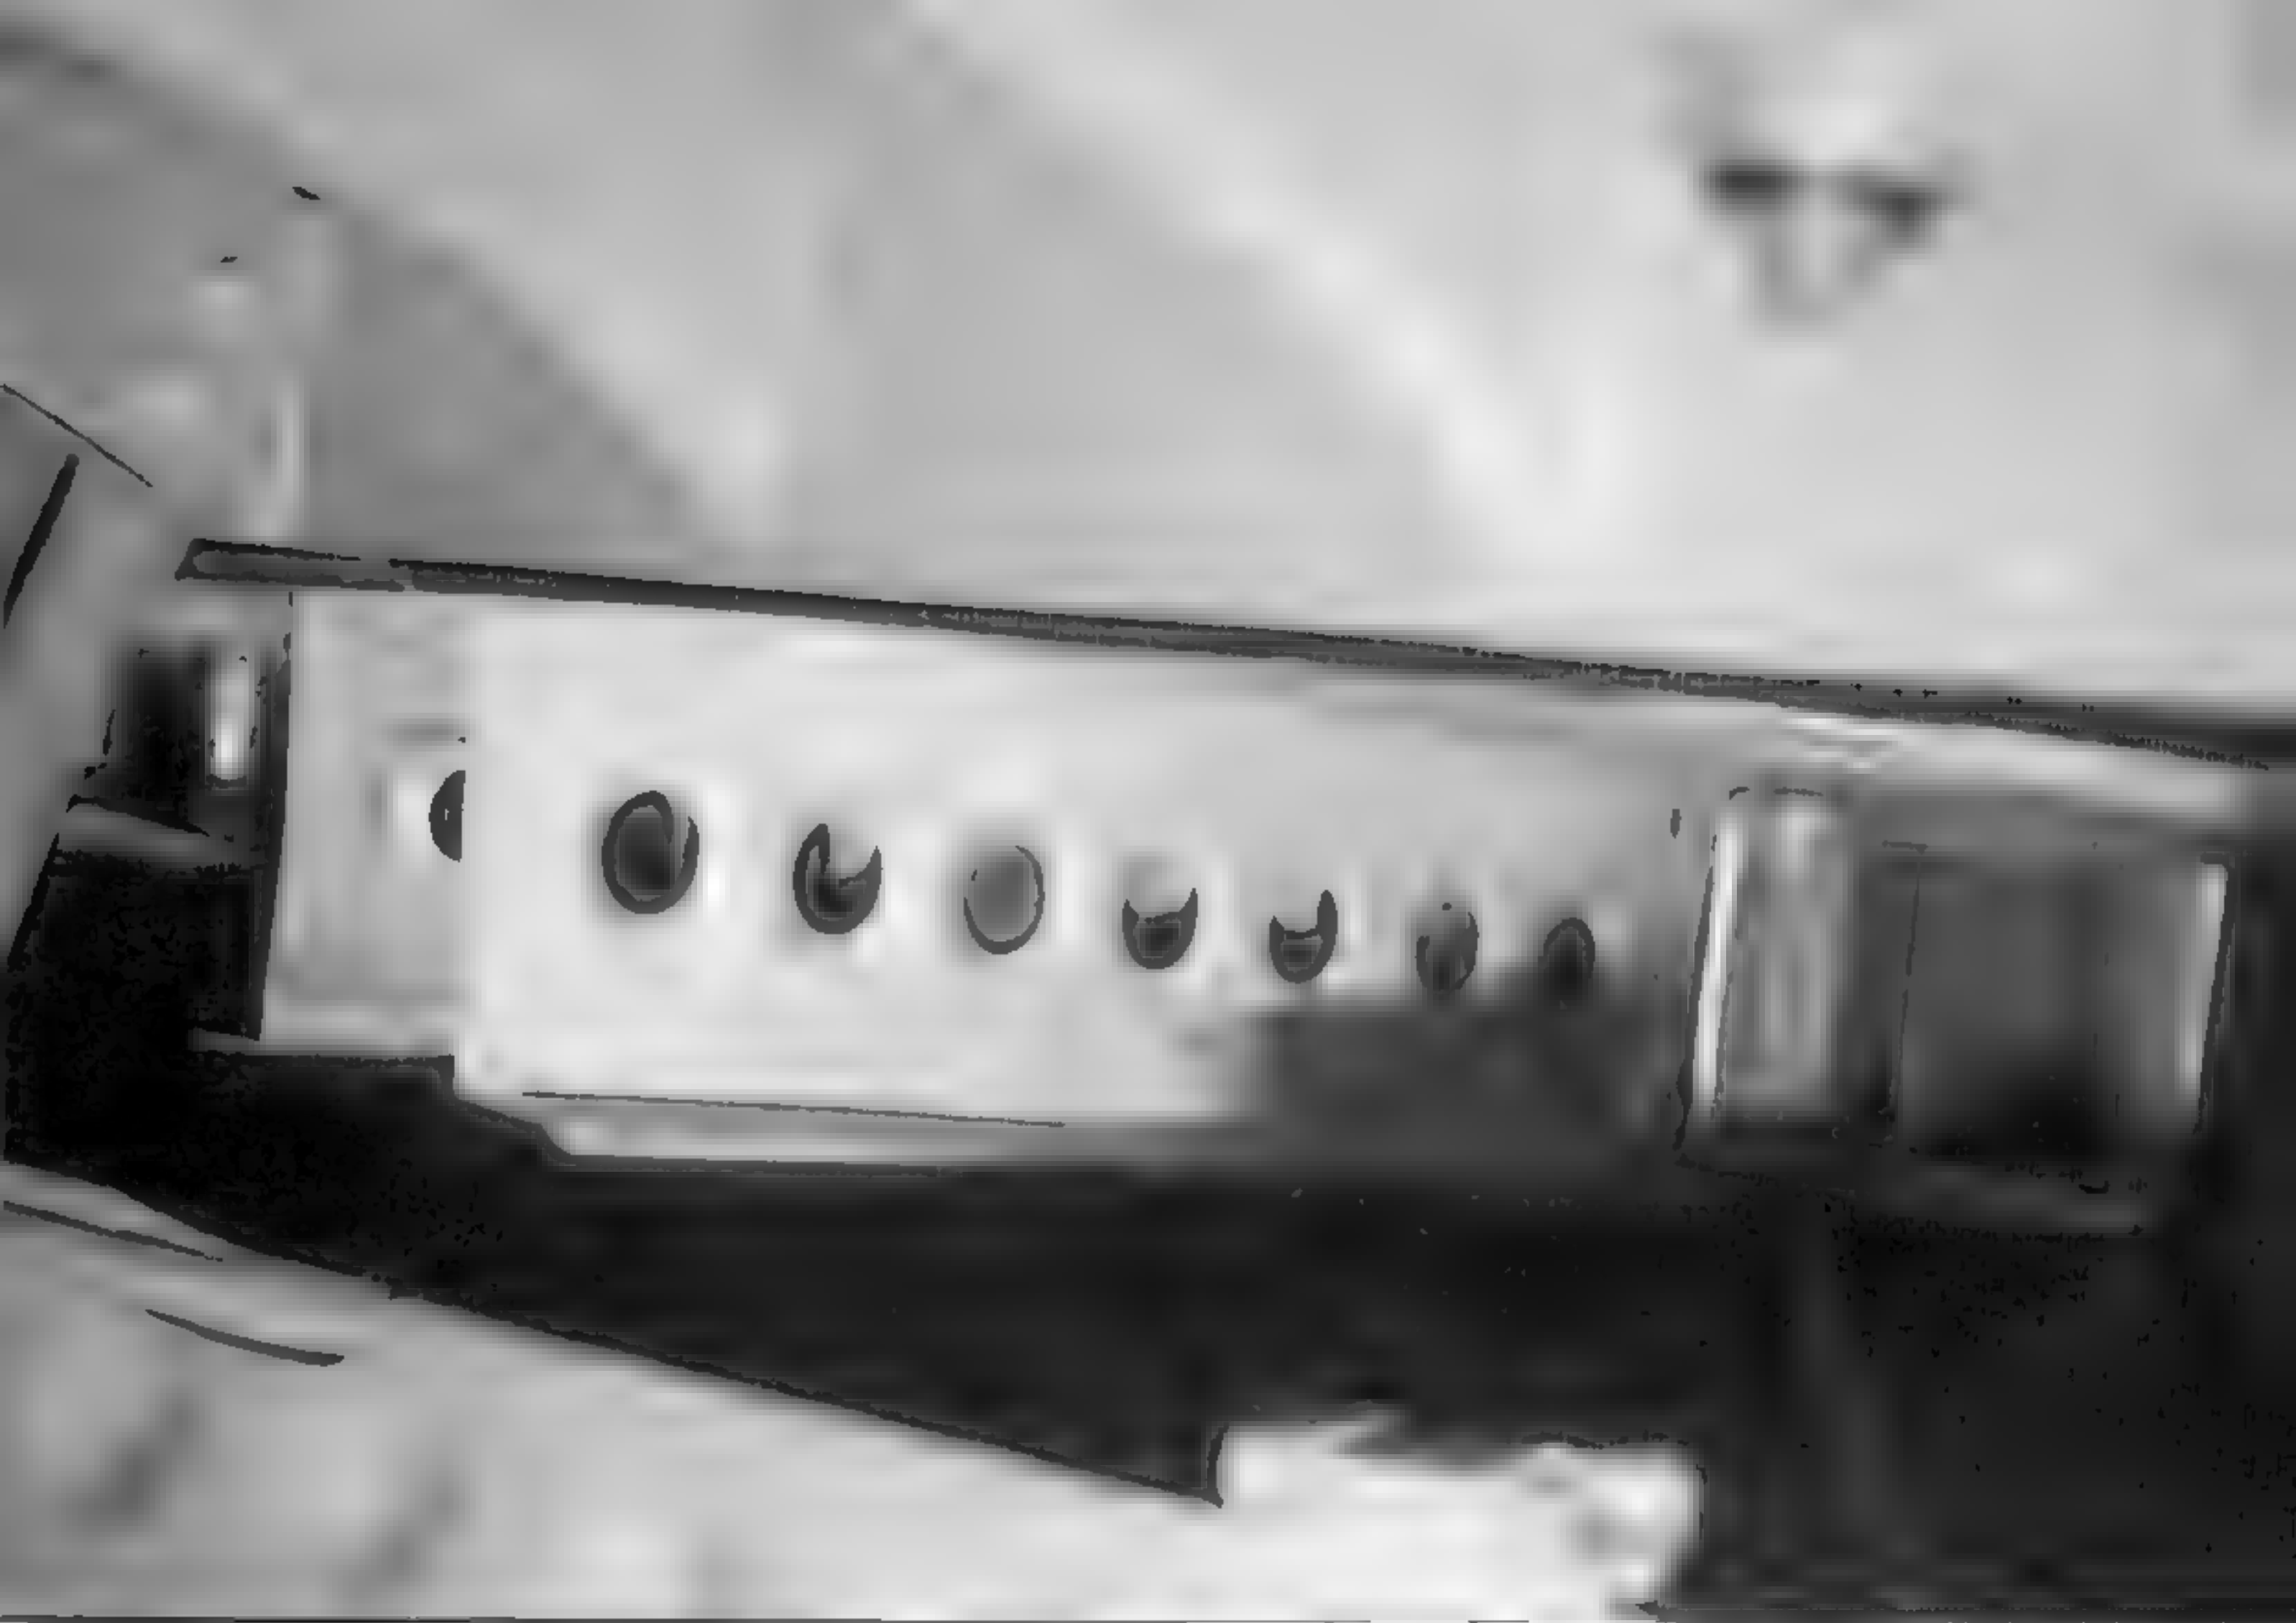
The ammunition box guide brackets for the cowl-mounted 13MM MG 131 machine guns are attached to the fuselage firewall above the main wing spar. The ammunition boxes extended into the wheel well and used a hinged belt and cartridge casing chute (not installed) which extended through the wheel well to the two cowling gun ejection ports in the wing under surface. This photograph shows the area immediately above the wheel well cowling in the preceding photograph. (Ryle)
